GEMP-640

CREEP FAILURE MODES IN ARC-CAST AND POWDER METALLURGIC TUNGSTEKS¹

R. C. Rau and F. T. Williams, Jr.
General Electric Company
Nuclear Systems Programs
Cincinnati, Ohio 45215

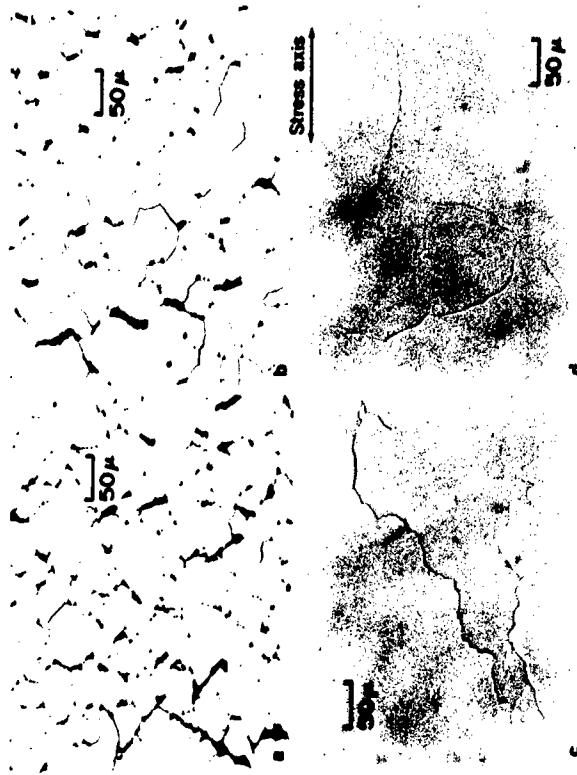
Optical microscopy of the as-polished surfaces showed an abundance of grain boundary cavities in the powder metallurgy tungsten, and an almost total lack of such cavities in the arc-cast material. Representative micrographs are presented in Fig. 1, where Figs. 1(a) and (b) refer to powder metallurgy material, and Figs. 1(c) and (d) refer to arc-cast material.

As illustrated by these micrographs, the powder metallurgy material consisted of fairly equiaxed grains, which increased in average size with increasing test temperature. Grain boundary separation and cavitation were very pronounced, especially along boundaries which were transverse to the stress direction. On the other hand, arc-cast material was composed of very large grains, which extended across the total thickness of the specimens, and showed practically no tendency to form cavities. A rare instance of a grain boundary cavity in the arc-cast specimen tested at 1600°C is arrowed in Fig. 1(c).

Replica electron microscopy of the powder metallurgy samples showed that the mode of fracture was almost totally intergranular, especially for the lower temperature, higher stress conditions, and that the exposed grain boundary surfaces contained a profusion of cavities. Typical examples are illustrated in Fig. 2. At lower temperatures the voids were usually irregular in shape, tending to be relatively flattened along the boundary surface and often containing elongated "fingers", suggestive of void coalescence, Fig. 2(a). Such cavities are termed wedge-shaped, or w-type (4), and are believed to originate primarily by grain boundary

In contrast to the powder metallurgy material, replica electron micrographs of the arc-cast tungsten showed that the fracture at all temperatures was predominantly transgranular, as illustrated in Fig. 3(a). When grain boundary surfaces were seen, they were always relatively clean and contained only a few small irregularities suggestive of cavities, Fig. 3(b). In none of these samples was any evidence seen of cavity coalescence or polyhedral shaped voids.

Figure 1. Optical micrographs of creep-rupture tested tungsten in as-polished condition. (a) Powder metallurgy specimen tested at 1600°C and 4.22 kg/mm². (b) Powder metallurgy specimen tested at 2000°C and 2.11 kg/mm². (c) Arc-cast specimen tested at 1600°C and 4.22 kg/mm². (d) Arc-cast specimen tested at 2000°C and 2.11 kg/mm².

Figure 2. Electron fractographs of powder metallurgy tungsten.
 (a) Irregular creep cavities in specimen tested at 1600°C and 4.22 kg/mm². (b) Polyhedral shaped voids in specimen tested at 2600°C and 0.70 kg/mm². (c) Cavities along a grain boundary triple junction in specimen tested at 2600°C and 0.84 kg/mm².

Figure 3. Electron fractographs of arc-cast tungsten.
 (a) Transgranular fracture in specimen tested at 2000°C and 2.11 kg/mm².
 (b) Grain boundary surface in specimen tested at 1600°C and 4.22 kg/mm².
